Manhole Inspection Summary

Manhole # S19C__025MH

Location Address: **2111 EDMONDSON-FRANKLIN** Cross Street: **BENTALOU-PULASKI**

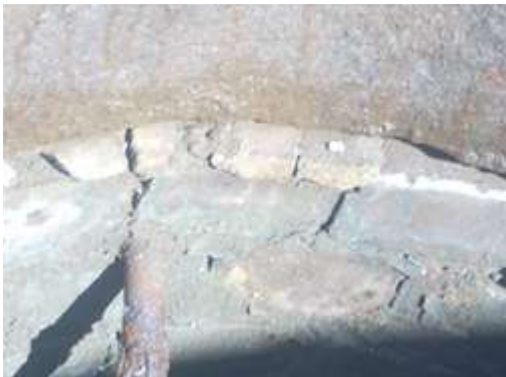
Defect 3

Condition: ☐ Sound ☐ Cracked ☐ Root Intrusion ☐ Loose Brick ☒ **Deteriorated**

CHIMNEY DETERIORATION

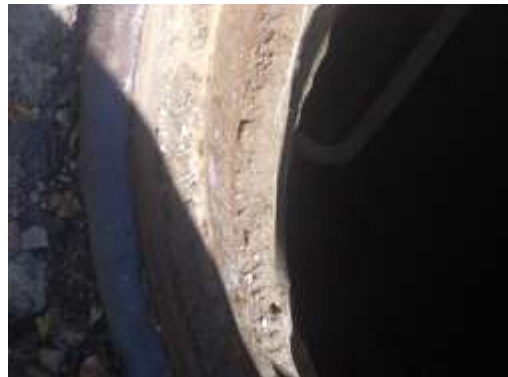
Defect 2

Frame Offset: **1** (in.) Condition: ☒ Sound ☐ Cracked ☐ Leaks

FRAME OFFSET

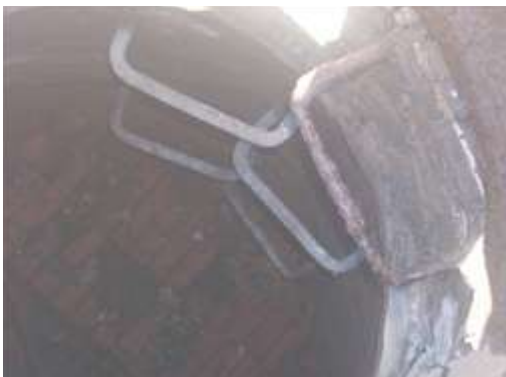
Defect 1

Steps Count: **5** Missing: **0** ☒ **Corroded**

CORRODED STEP

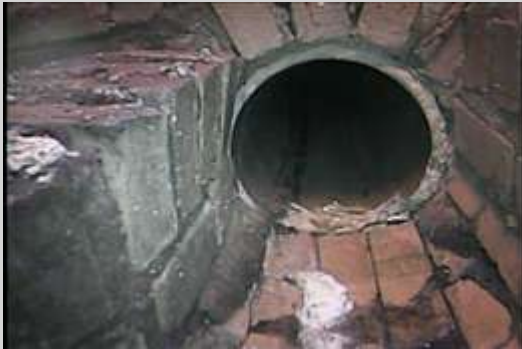
12 O'Clock Outflow

Pipe Height: **8.4** (in.) Rod and Bar (Angled)
Pipe Material: **Clay** ☐ Pipe Lined
Invert Depth: **8.10** (ft.) Flow Characteristics: **Slow**
Deposits: ☒ None ☐ Mud ☐ Sludge ☐ **Debris** ☐ Grease
Silt Depth: (in.) Deposits Extent:
Infiltration: **None** Pipe Seal Cond: **Sound**

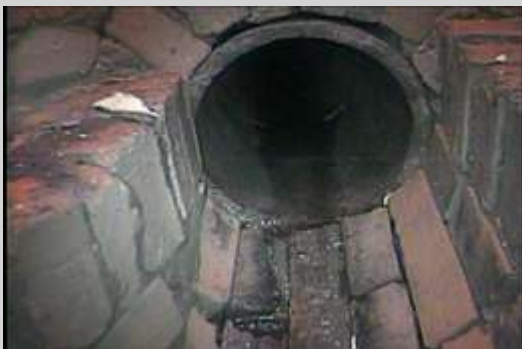
3 O'Clock Inflow

Pipe Height: **8.4** (in.) Rod and Bar (Angled)
Pipe Material: **Clay** ☐ Pipe Lined
Invert Depth: **7.72** (ft.) Flow Characteristics: **Slow**
Deposits: ☒ None ☐ Mud ☐ Sludge ☐ **Debris** ☐ Grease
Silt Depth: (in.) Deposits Extent:
Infiltration: **None** Pipe Seal Cond: **Sound**

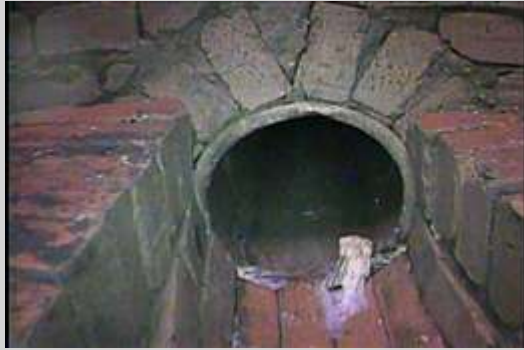
9 O'Clock Inflow

Deposits: ☐ None ☐ Mud ☐ Sludge ☒ **Debris** ☐ Grease

Silt Depth: **1** (in.) Deposits Extent: **Light**
